F23 Hedgebank Walls

Bolders, Soil, Turf mortar and Hedging

Site Autonomy

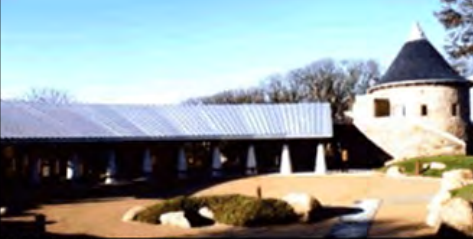
Pembrokeshire hedge bank

Random rubble & slate outer leaves, wild turf mortar, soil cavity fill, turf or hedge plants on top, crevices for nature, rain will rejuvenate it in weeks

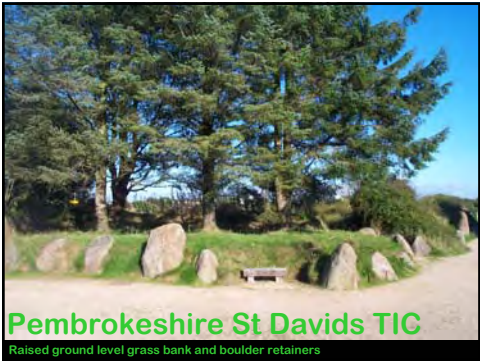
Pembrokeshire St Davids TIC
Raised ground level grass bank and boulder retainers

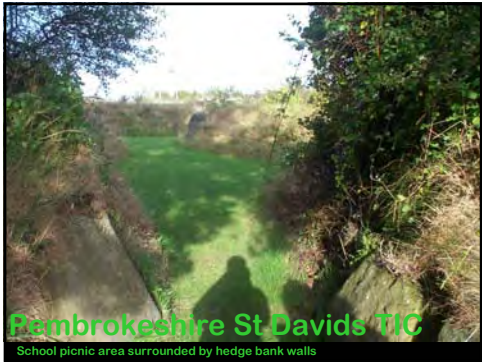
Pembrokeshire St Davids TIC
School picnic area surrounded by hedge bank walls
